HITLER'S TANKS

GERMAN PANZERS OF WORLD WAR II

EDITED BY
CHRIS McNAB

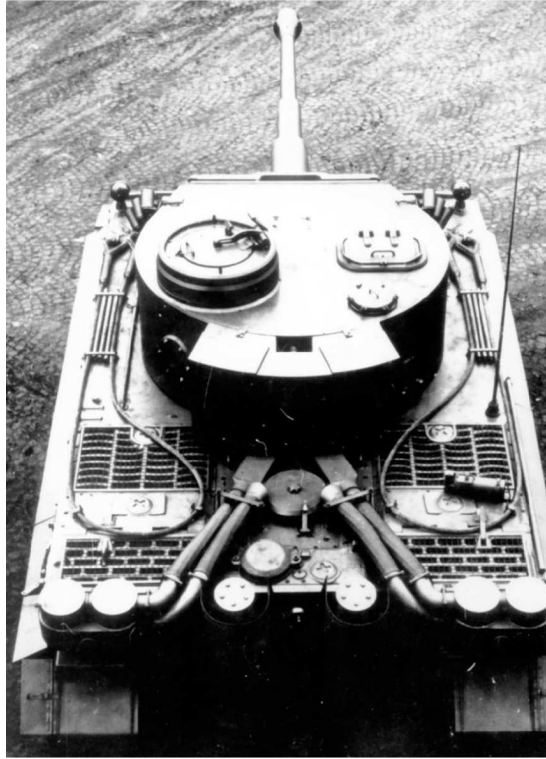
A top rear view of a PzKpfw VI Ausf E Tiger I, clearly showing the pipework leading out to the Feifel air filters. (AirSeaLand/Cody)

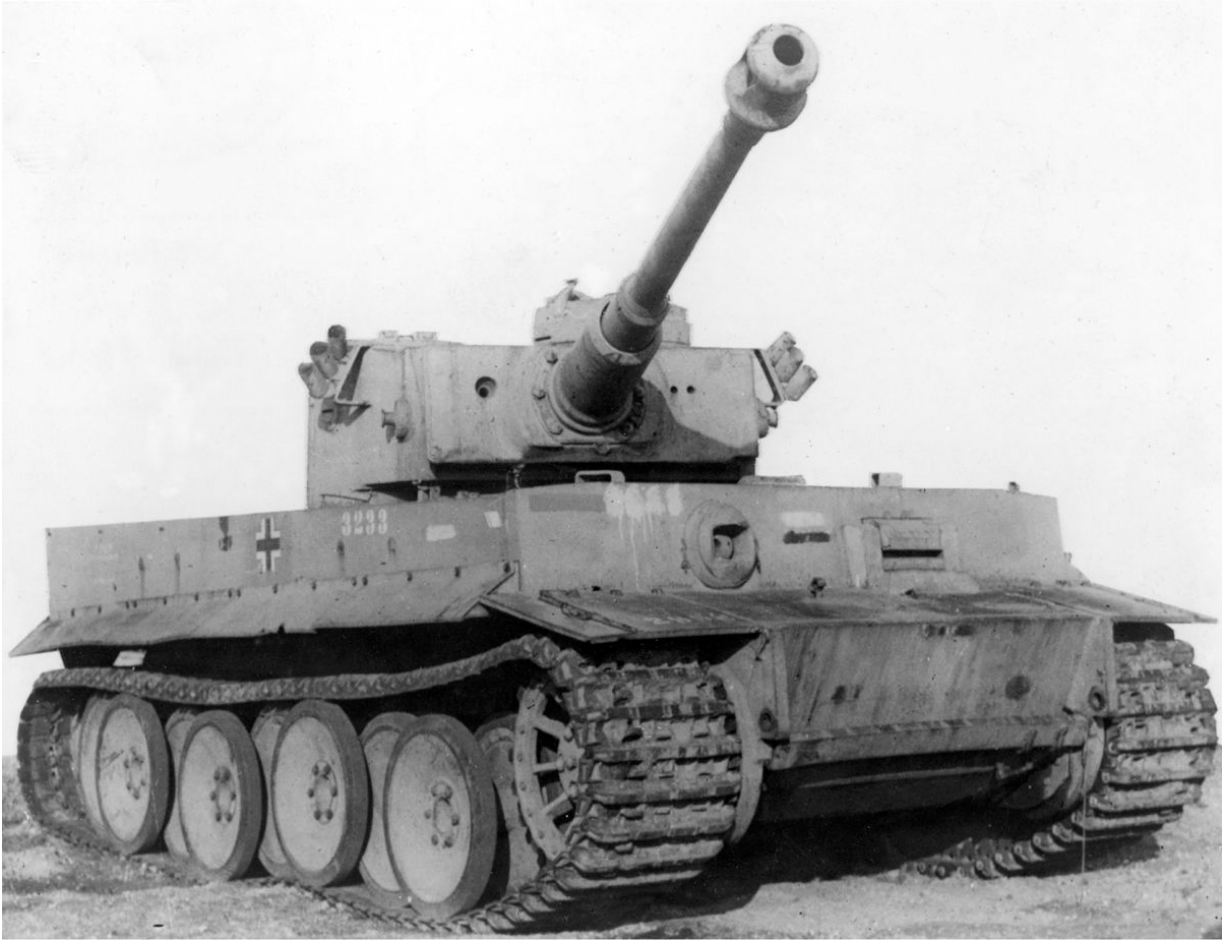
A PzKpfw VI Ausf A Tiger I. Note how three smoke grenade dischargers are fitted to each side of the turret; these were positioned to create a pattern of smoke when fired simultaneously. (AirSeaLand/Cody)

Starting with Turm Nr 286, the *Nebelwurfgeräte* (smoke candle dischargers) were no longer mounted on the right and left turret sides for the same reason as for the Panther. During a reported action in February 1943, small-arms fire had set off the smoke candles which had temporarily incapacitated the crew members. Starting with Fgst Nr 250301, the forward shock absorbers were fastened using mounting bolts with a large external head because the previous conical head design had vibrated loose.

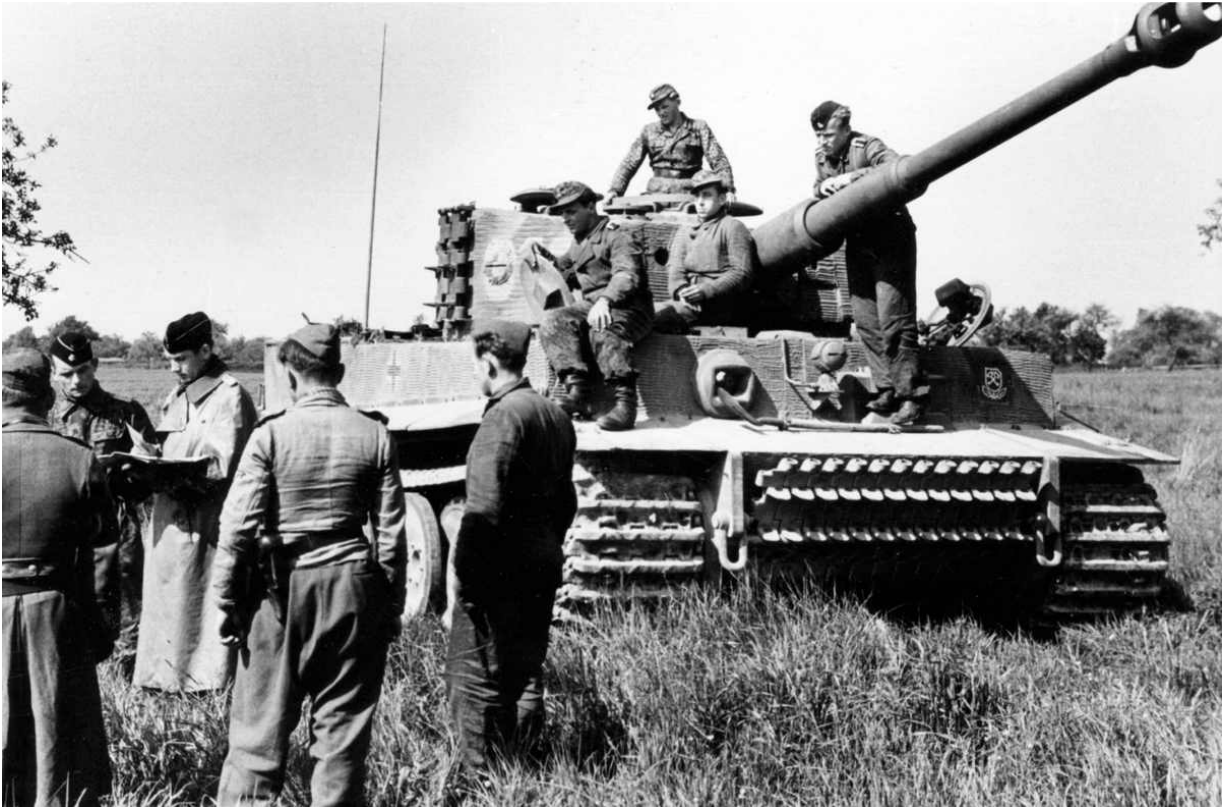
A PzKpfw VI Ausf A Tiger I of the I. SS-Panzer-Corps. The extent of the Zimmerit anti-magnetic mine paste covering is evident in this photograph. (AirSeaLand/Cody)

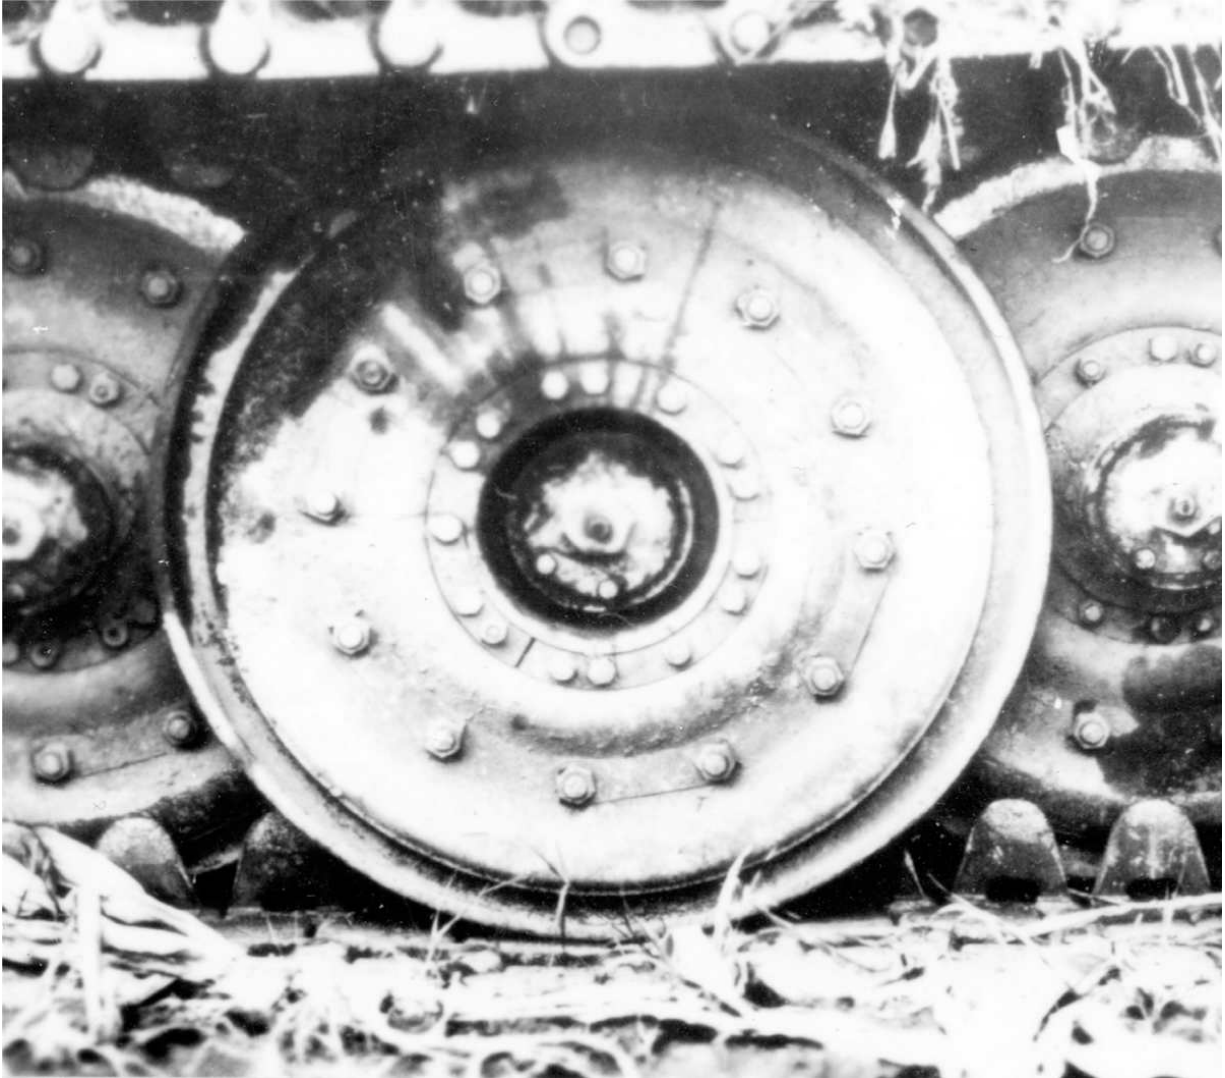
A close-up of the track and overlapping *Gummigefederten Stahllaufrollen* (steel road wheels with internal rubber cushioning) on a PzKpfw VI Ausf E Tiger I. (AirSeaLand/Cody)

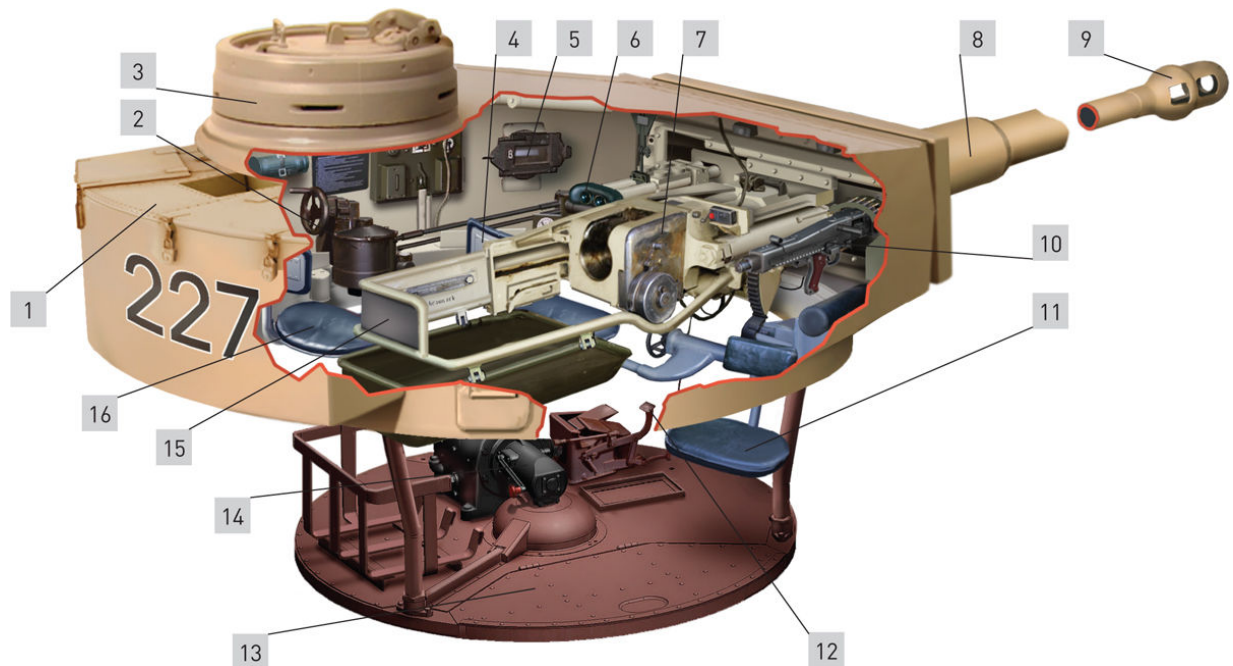
TIGER I TURRET

- 1.** Turret stowage bin
- 2.** Gunner's turret stowage
- 3.** Commander's vision cupola
- 4.** Gunner's seat
- 5.** Gunner's side vision port
- 6.** Gunner's telescopic sight
- 7.** 8.8cm gun breech
- 8.** 8.8cm gun
- 9.** Muzzle brake
- 10.** Co-axial MG 34 machine gun
- 11.** Loader's seat
- 12.** Gunner's foot control pedal
- 13.** Turret basket floor
- 14.** Turret traverse motor

- 15. Spent casing buffer and gun safety guard
- 16. Commander's seat

The Tiger tank commander (*Panzerführer*) was stationed in the left rear of the turret below an armoured cupola. Sitting in front of the tank commander was the gunner (*Richtschütze*), with the main gun against his right shoulder. In the initial versions of the Tiger I, the gunner's main instrument was a TZF 9b binocular telescopic sight, but as an economy measure, this was replaced by a TZF 9c monocular sight on the later models of the Tiger I. The gunner did not have a periscopic sight for general observation during travel. As a result, he depended on the tank commander for targeting instructions. This was not a significant problem when the Tiger was static and looking for targets, but it slowed the firing cycle to about 20–30 seconds when the Tiger had to engage targets while on the move. The loader (*Ladeschütze*) stood in the right side of the turret during combat operations, or sat on a small fold-out seat. The position was relatively spacious compared to the left side of the turret. The ammunition stowage was 92 rounds on the Tiger I and 72 rounds on the Tiger II. The 8.8cm ammunition was quite substantial, weighing 16kg for the KwK 36 on the Tiger I with a length of 0.9m. The 8.8cm projectiles for the KwK 43 gun on the Tiger II were longer and heavier, weighing about 23kg. The driver (*Fahrer*) sat in the left front of the hull, and the radio was positioned in the hull next to the radio-operator (*Funker*), who sat in the right front corner of the hull opposite the driver. The radio-operator's main role was to operate the tank's Fu 5 SE 10U radio transceiver which was located to his left. All tanks in a Tiger company operated on a single, predetermined channel; according to doctrine, only the company commander (and platoon commanders in an emergency) was to send voice messages so that they would be clearly picked up by all tanks in the company. A Tiger crewman from schwere Panzerkompanie Hummel recalled that in reality 'everybody talks all the time, except the company commander, who can hardly get a word in edgewise'. Besides operating the radio, the radio-operator also manned the bow machine gun, an MG 34 in a ball mount.

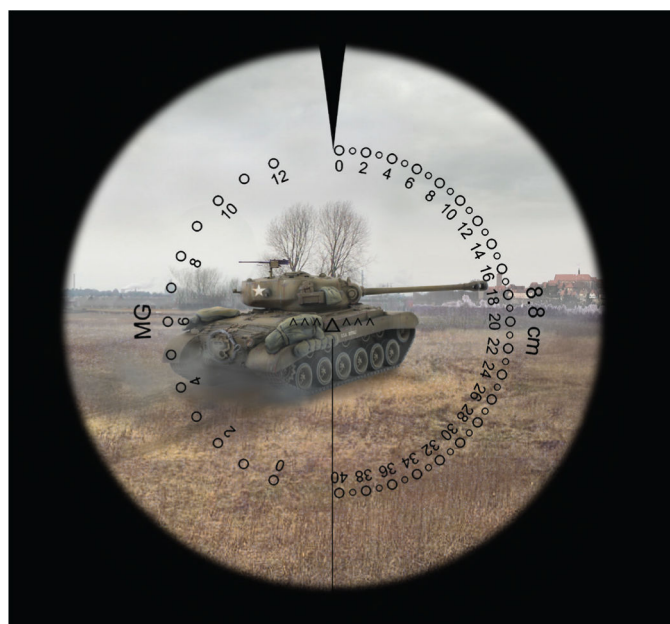
TZF 9C TELESCOPIC SIGHT

The Tiger I's 8.8cm KwK 36 gun was aimed through a TZF 9c monocular telescope in place of the binocular TZF 9b used in the earlier versions of the tank. The telescope offered 2.5× magnification. The TZF 9c telescopic sight had an engraved reticle consisting of an aiming triangle in the centre with smaller triangles on either side. The gunner placed the target at the apex of the centre triangle.

The monocular TZF 9c (sighting telescope) replaced the previously used binocular TZF 9b. Until gun mantlets became available which had not been drilled for the binocular sight, the additional aperture was welded shut with an armoured plug. Beginning with Fgst Nr 251075, wooden decking was installed over the top of the upper fuel tanks to catch artillery shell splinters and bullet splash that came through the cooling air grates on the rear deck.

With the replacement gun sight TZF 9c introduced in April 1944, the gunner could select two magnifications, 2.5× and 5×. The lower magnification provided a wider field of view for target identification, while the higher assisted in precise aiming at long ranges. Two adjustable range scales allowed the gunner to register the exact range to the target. The range scale was graduated in the same way as the 96 sight.

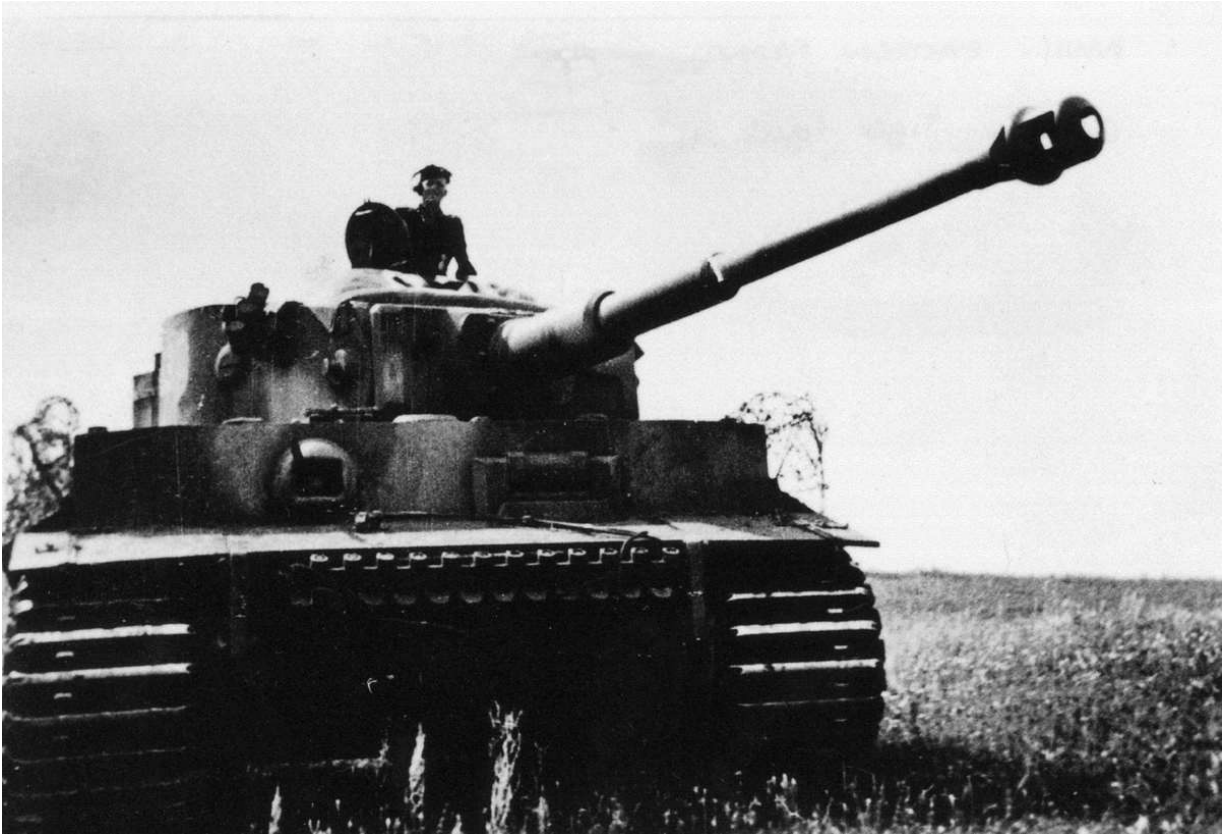
This PzKpfw VI Ausf E Tiger I appears to have improvised barbed wire on the sides of the vehicle, possibly to prevent enemy infantry approaching from the flanks to lay magnetic mines. (AirSeaLand/Cody)

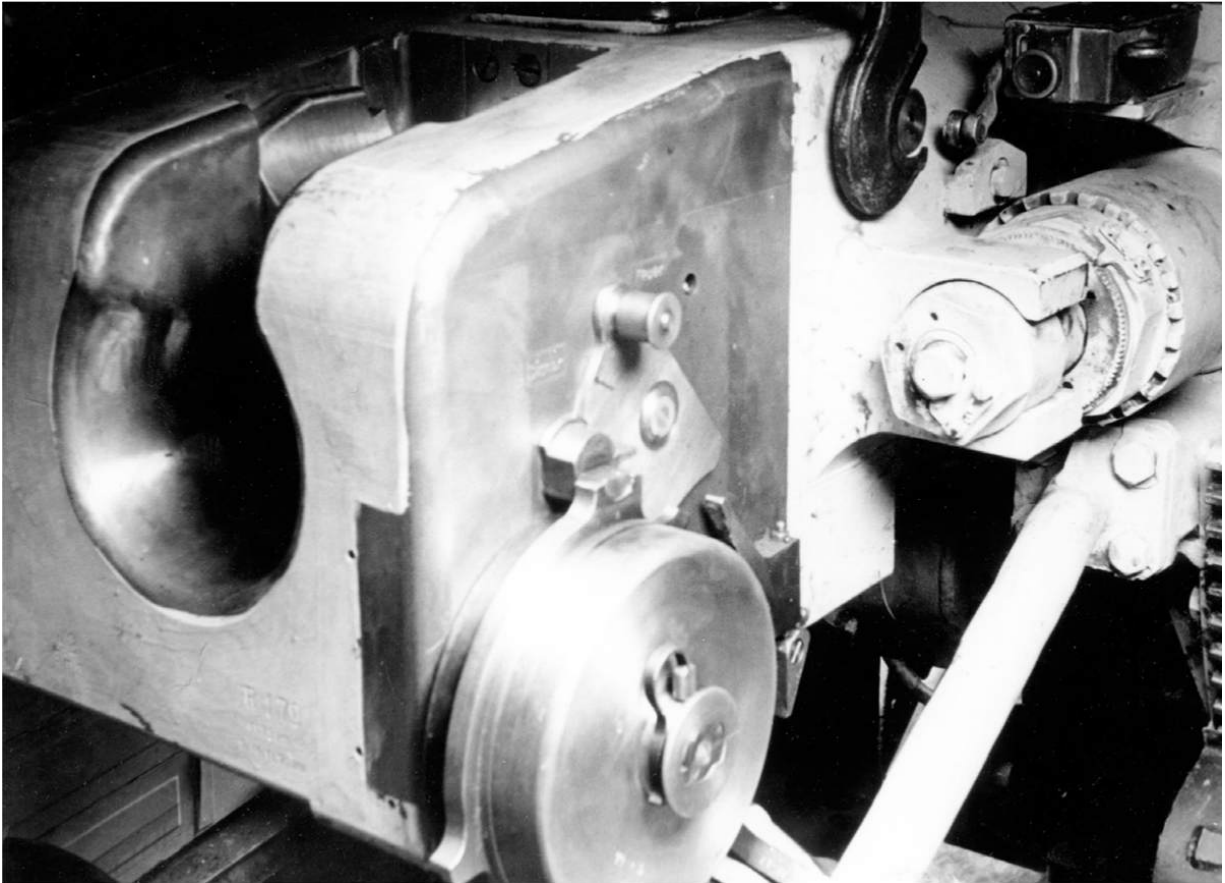
Inside the turret, a close-up of the Tiger I's main 8.8cm gun breech. A spent casing buffer and gun safety guard sat just behind the breech. (AirSeaLand/Cody)

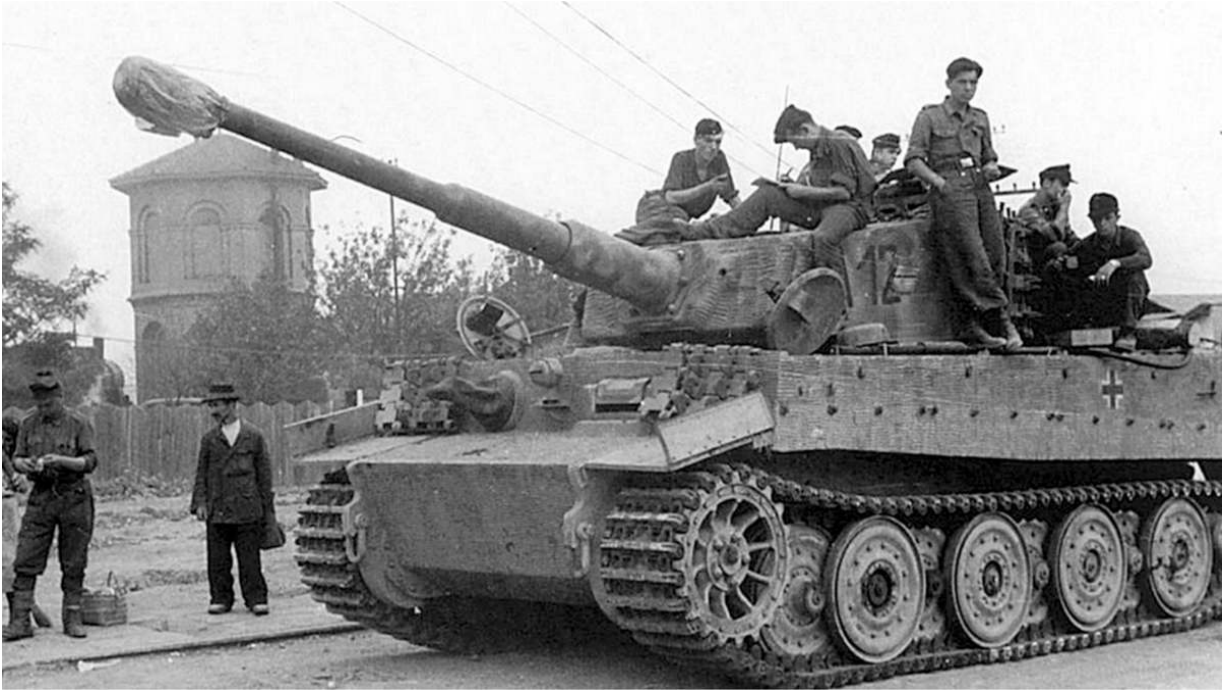
A PzKpfw VI Tiger I, on what appears to be the Eastern Front. On the mantlet, the tank has the single opening for the monocular sight that was introduced in April 1944.
(AirSeaLand/Cody)

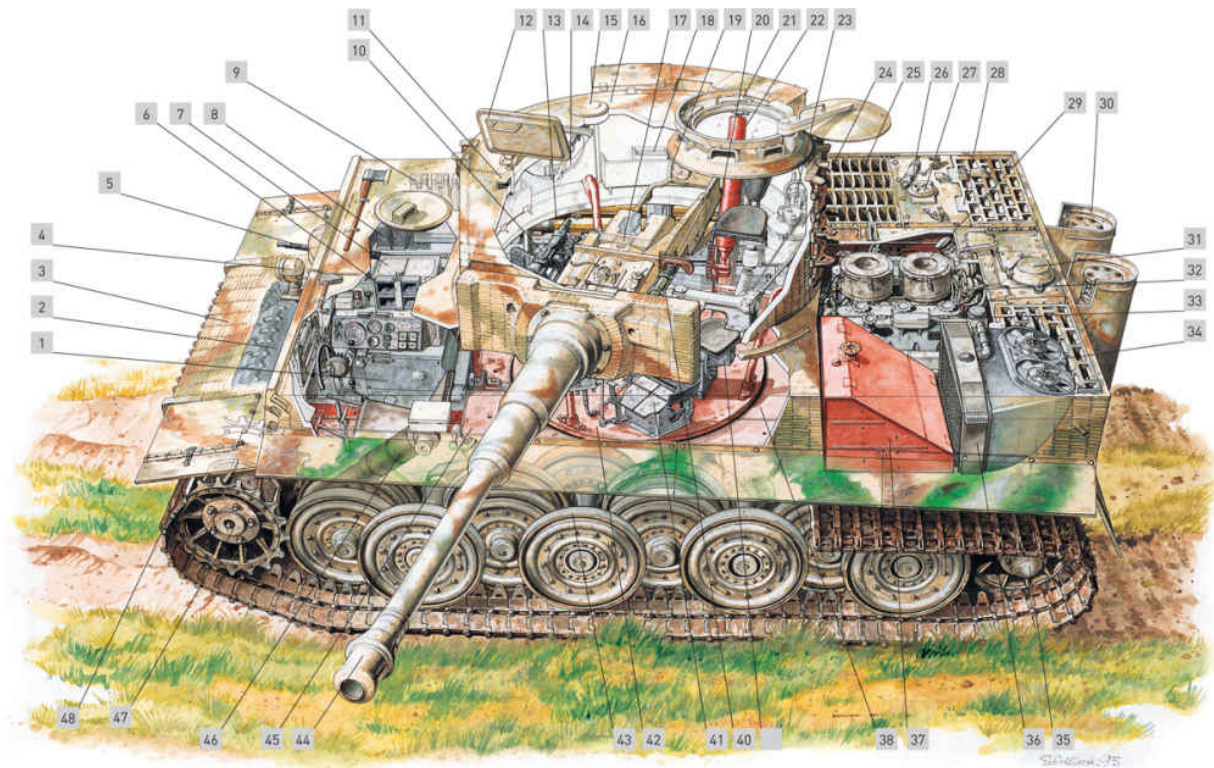
TIGER I, SCHWERE HEERES PANZER-ABTEILUNG 501; NORMANDY, 1944

- 1.** Maybach Olvar 40 12 16 gearbox
- 2.** Maybach L600C steering gear
- 3.** Zimmerit anti-magnetic paste
- 4.** Bosch headlight
- 5.** 7.92mm MG 34 hull machine gun
- 6.** Spare glass blocks for driver's visor
- 7.** Radio sets
- 8.** MG 34 ammunition
- 9.** Ammunition bags for machine gun

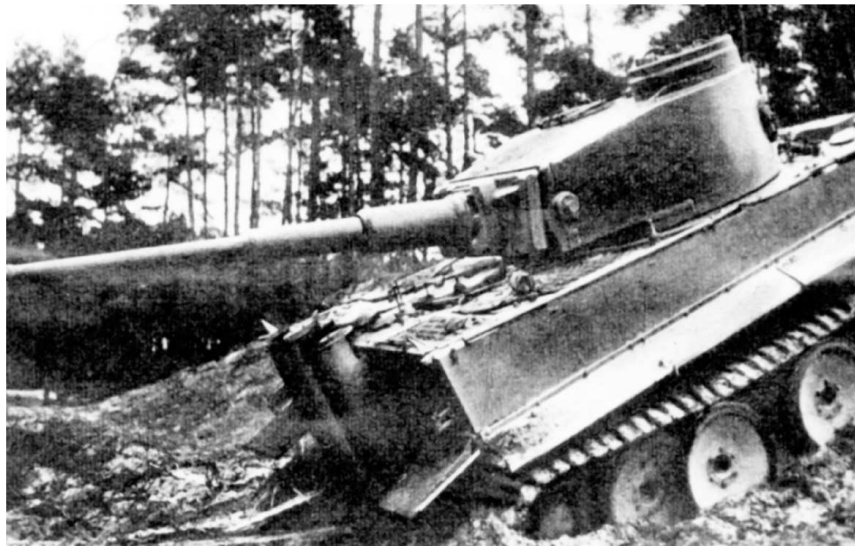
A ditched Tiger I. No dedicated armoured-recovery vehicle was manufactured for either the Tiger I or the Tiger II. (AirSeaLand/Cody)

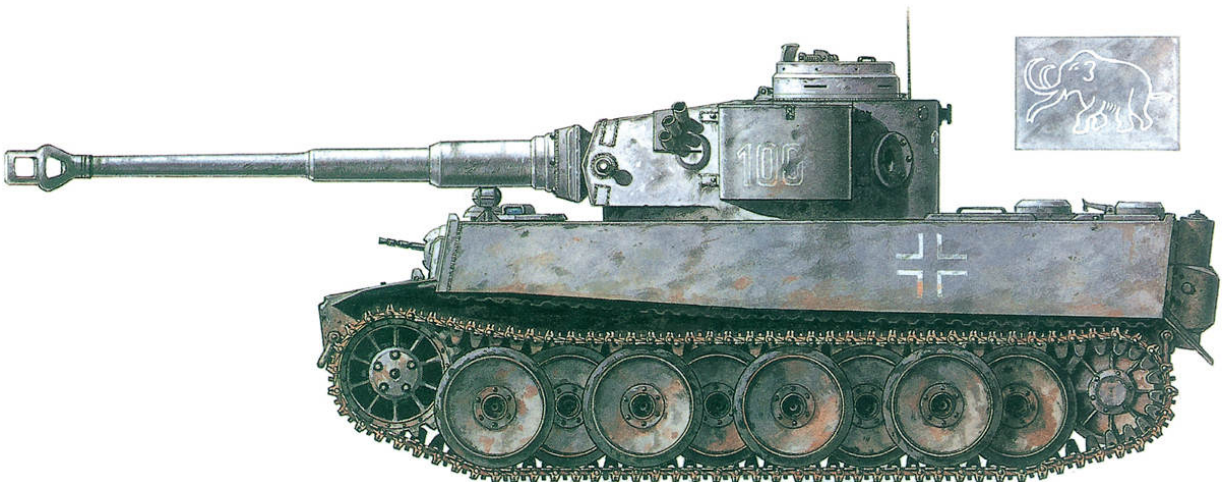
1) Tiger I, I. Kompanie/schwere Heeres Panzer-Abteilung 502; near Leningrad, January 1943. Four Tigers of the 1./schwere Heeres Panzer-Abteilung 502 were sent to the front near Leningrad and were the first to see action when committed near Mga on 29 August 1942.

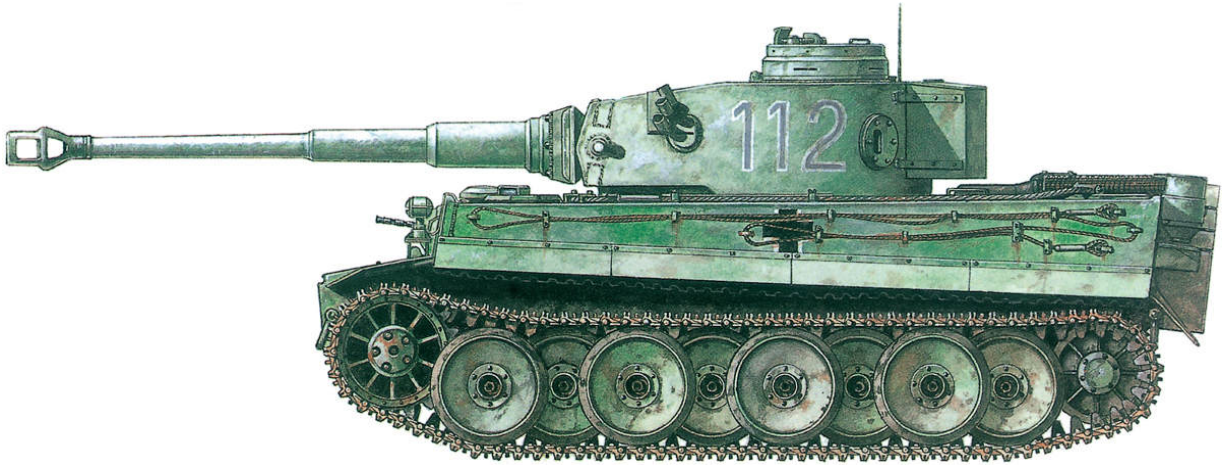
2) Tiger I, schwere Heeres Panzer-Abteilung 501; Tunisia, November 1942. The schwere Heeres Panzer-Abteilung 501 was one of the two Tiger units that had been promised to Rommel and prepared for tropical deployment. Originally outfitted with the Porsche-Tigers, the 501st was issued Henschel-Tigers due to the delays and cancellation of the Porsche-Tiger. The 501st was originally outfitted with 20 Tigers and 25 PzKpfw III (7.5cm) Ausf Ns, which were shipped to Tunisia between November 1942 and January 1943.

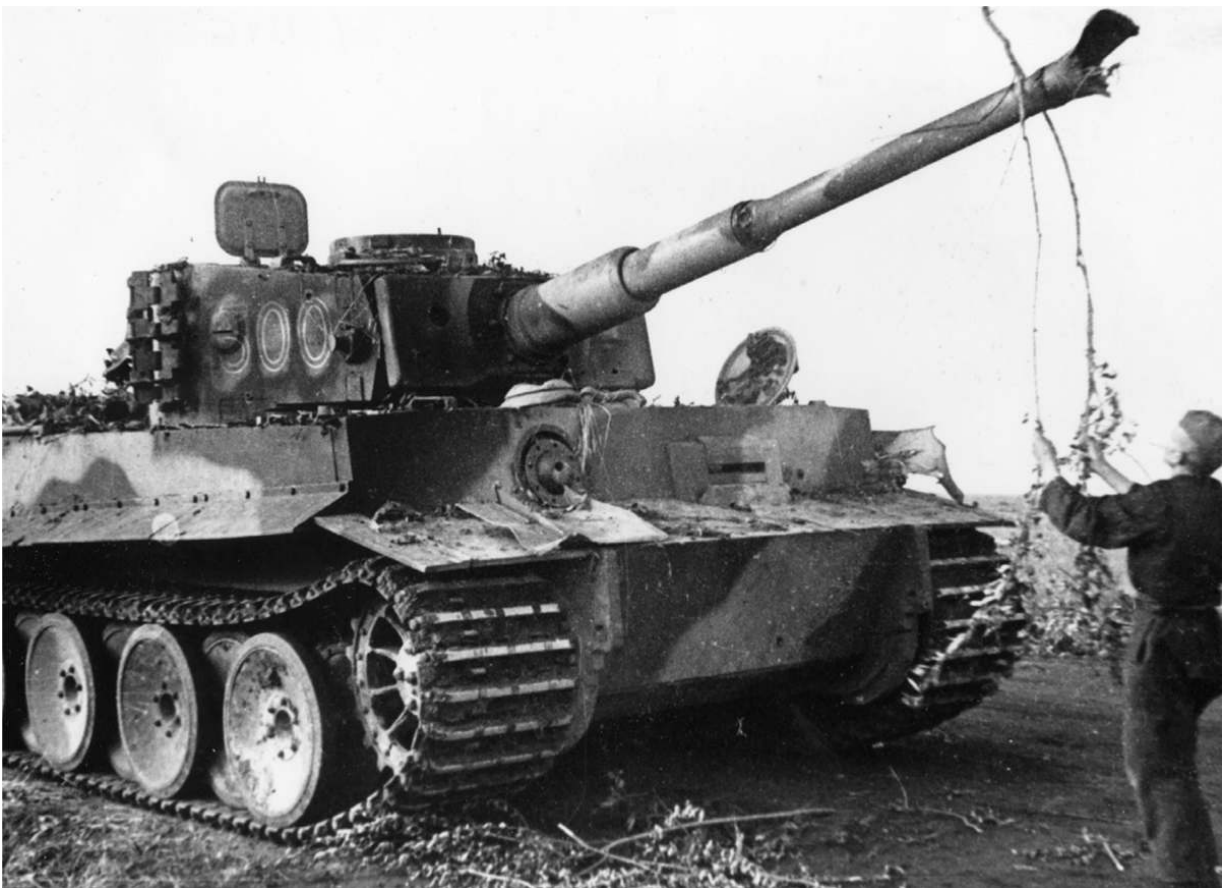
This Tiger I appears to have been destroyed by its crew before being abandoned; the split muzzle was usually a sign of putting a grenade or demolition charge into the barrel, to wreck the gun. (AirSeaLand/Cody)

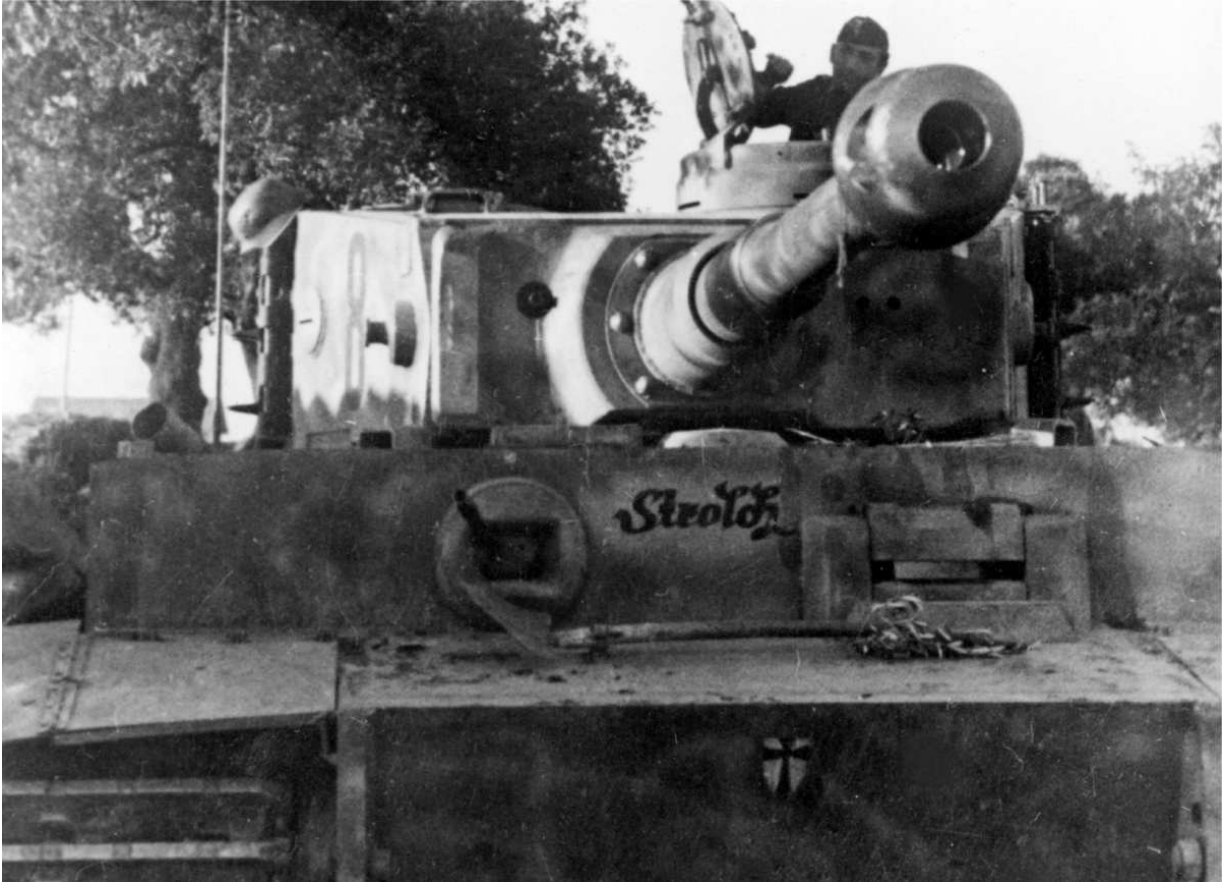
PzKpfw VI Ausf H1 Tiger I. The planned H2 turret was designed by Rheinmetall-Borsig and was supposed to be mounted on the 101st Henschel Tiger chassis. This Tiger variant was cancelled in July 1942 when the decision was made to continue production of the Ausf H1 with the 8.8 cm KwK L/56. The deadly L/70 gun was mounted in the Panther.

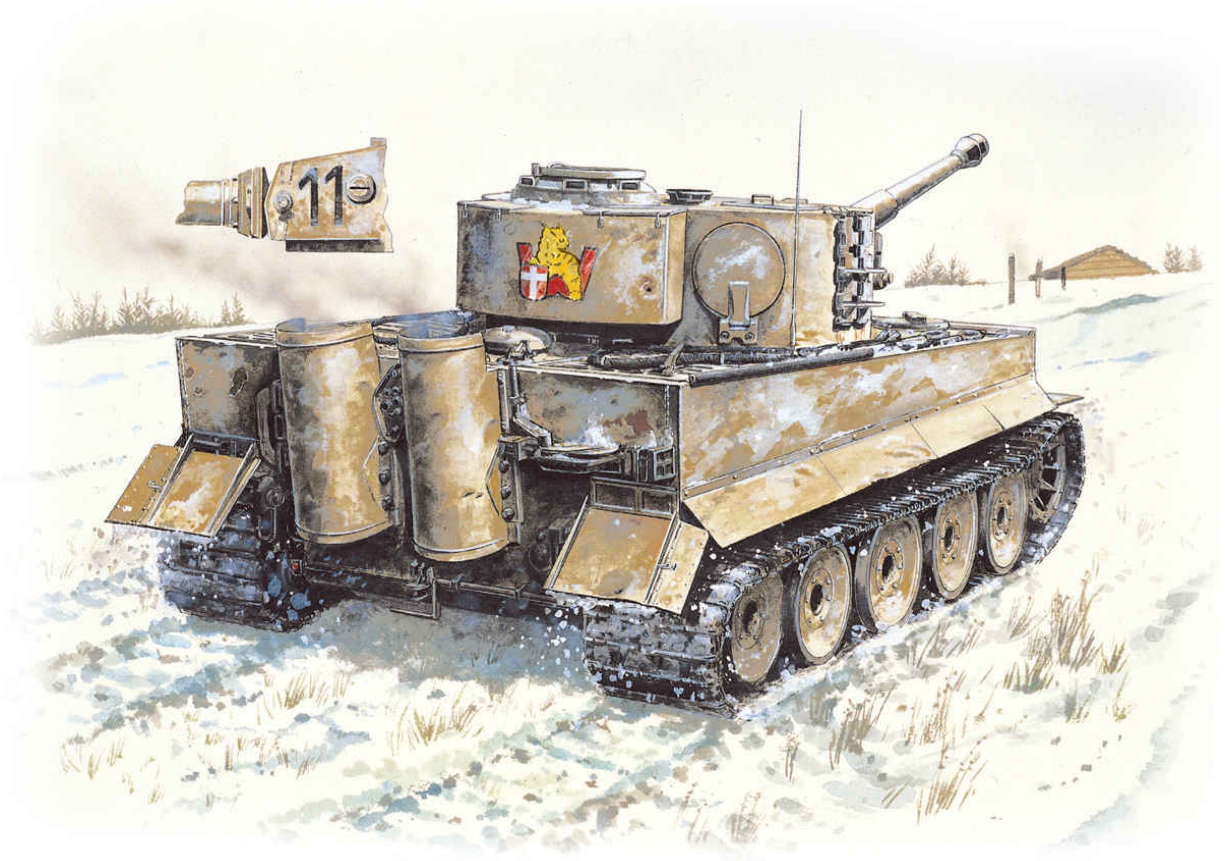
Tiger I, schwere Heeres Panzer-Abteilung 506; Russia, 1943. The schwere Heeres Panzer-Abteilung 506, formed in July 1943, was the first to adopt the new organization with a complement of 45 Tigers from the very beginning. Issued their 45 Tigers in August 1943, the 506th was sent to the Eastern Front in September.

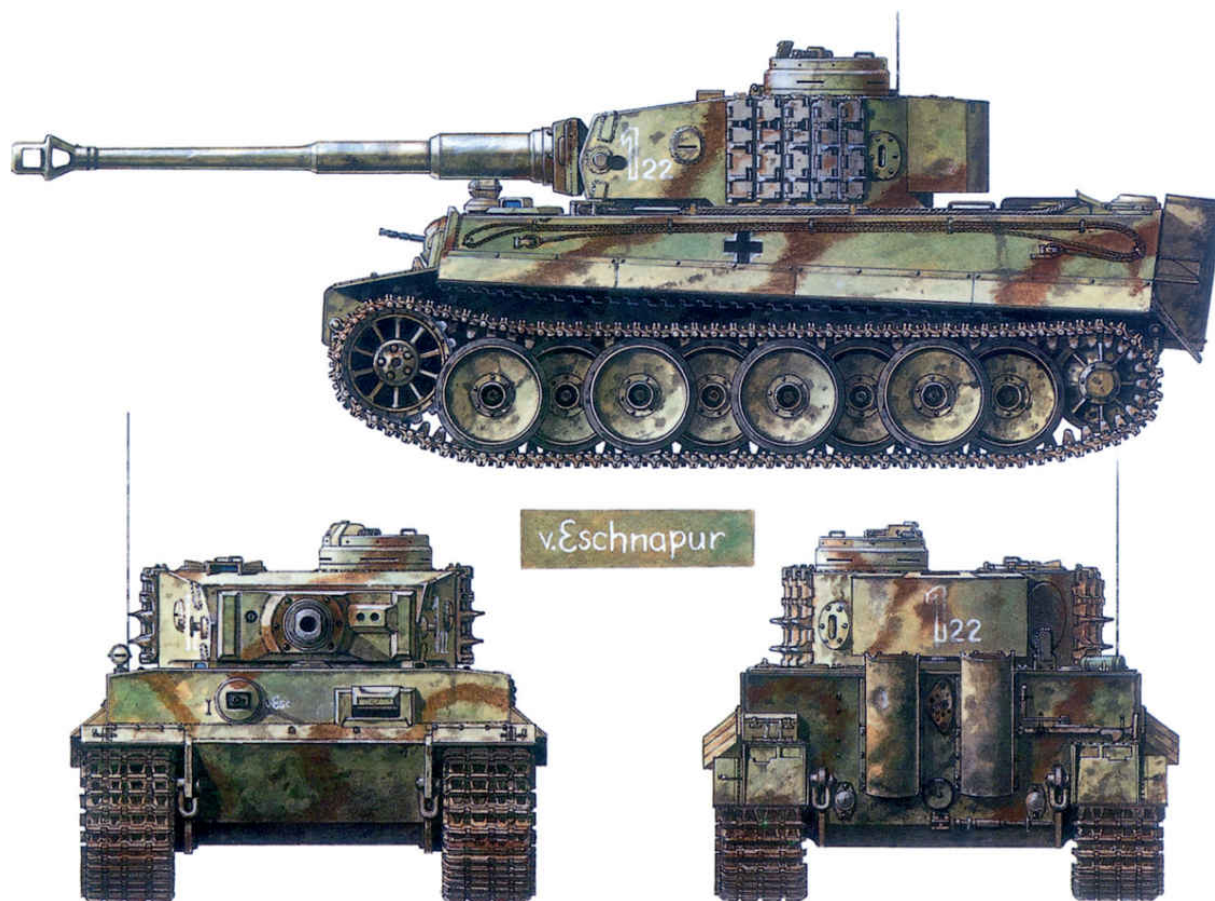
Tiger I, schwere Heeres Panzer-Abteilung 508; Italy, 1943. This Tiger was one of eight shipped from the ordnance depot to Tigergruppe Meyer on 28 July 1943. As was the custom in this Tigergruppe, the Tigers were given names, in this case *v.Eschnapur* in white on the driver's front plate, apparently getting the idea from the then popular adventure film *Der Tiger von Eschnapur*.

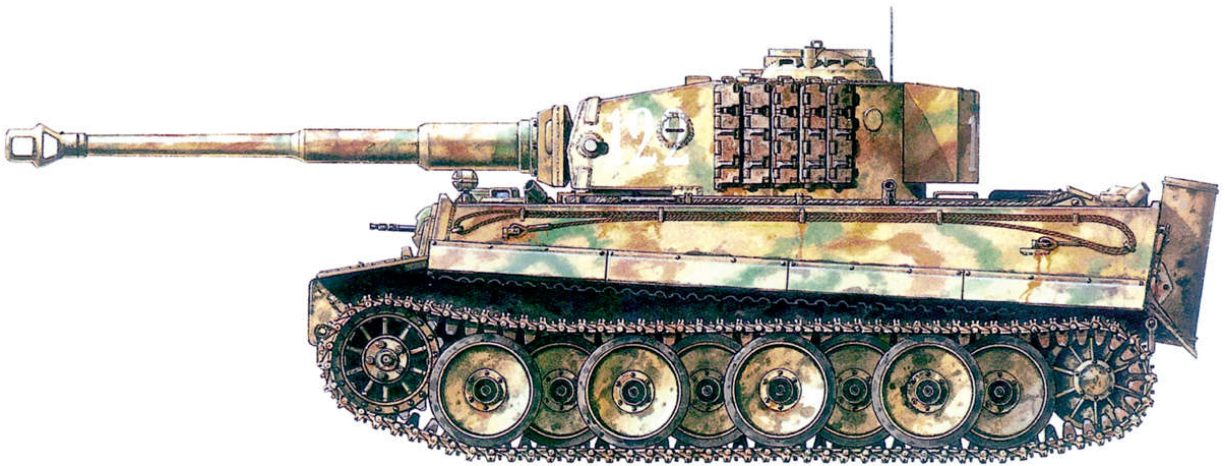
- 1) **Tiger I, schwere Heeres Panzer-Abteilung 509; Russia, late 1943.** This Tiger I, tactical number '122', of the schwere Heeres Panzer-Abteilung 509 saw action in the area of Shitomir in late 1943.

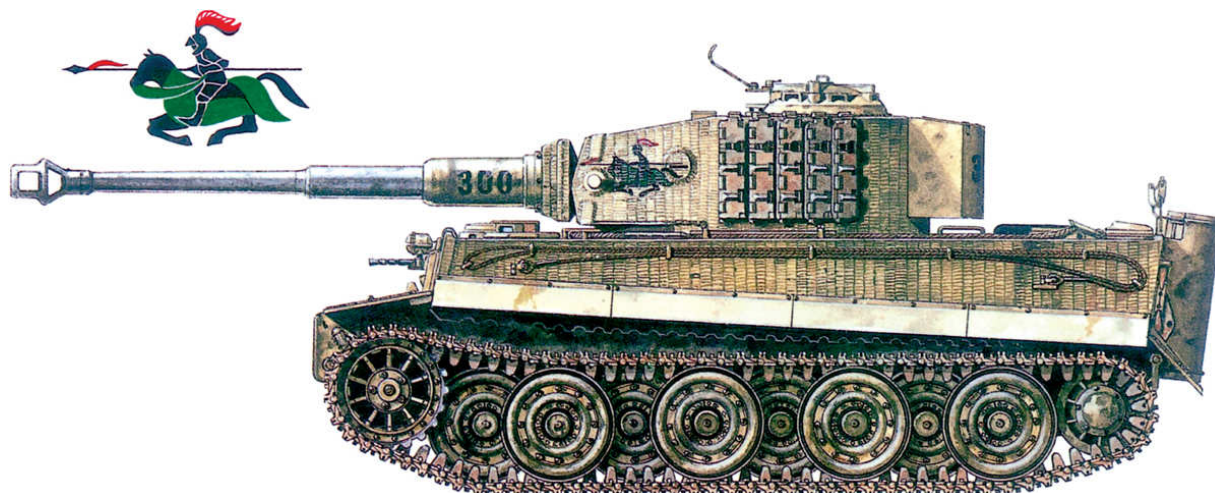
2) Tiger I, schwere Heeres Panzer-Abteilung 505; Russia, February 1944. The schwere Heeres Panzer Abteilung 505 had one of the most spectacular non-regulation markings. They painted their unit emblem, a knight on a charger, on both turret sides.

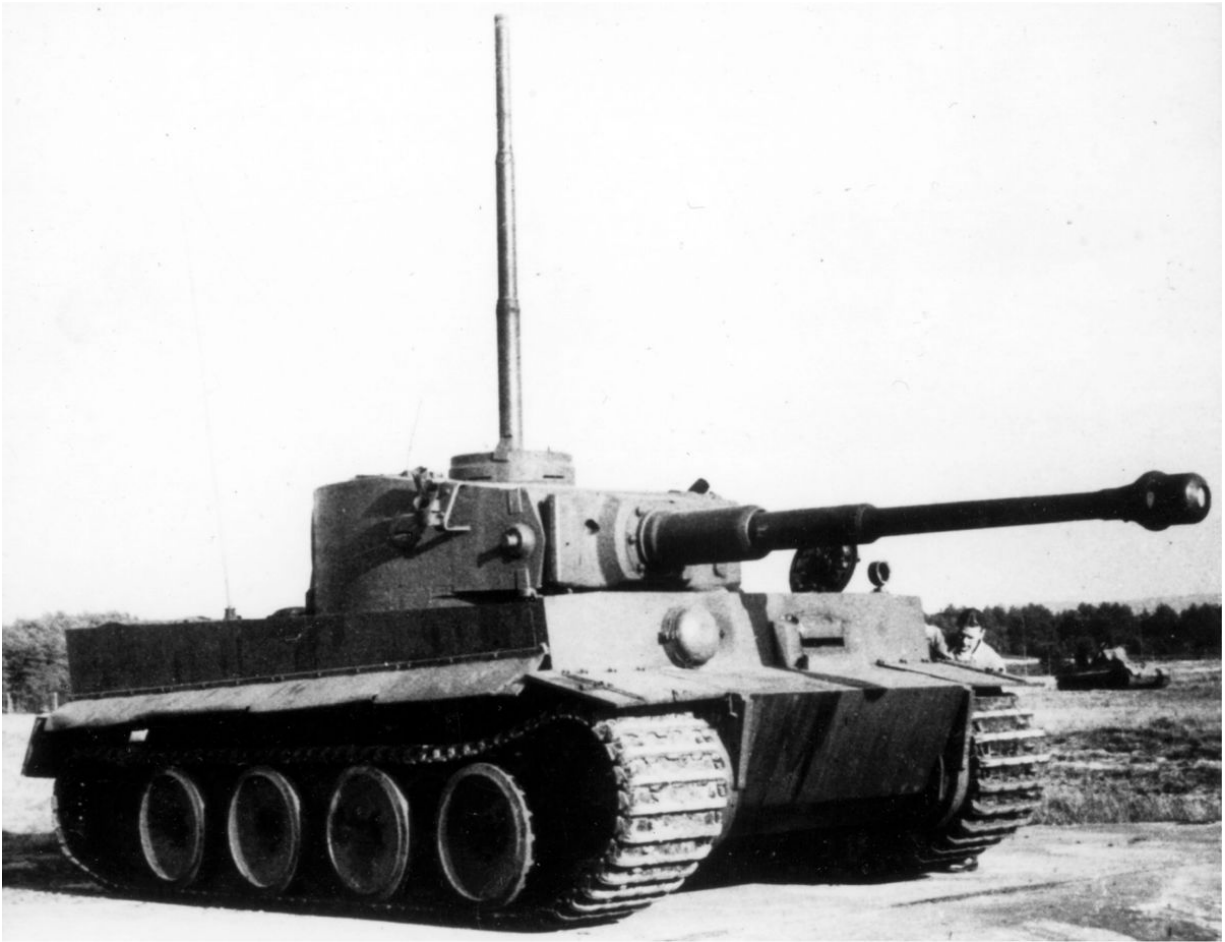
This PzKpfw VI Ausf E Tiger I has been fitted with a snorkel device for deep wading, although the practicalities of attempting to do so with such a large vehicle are questionable.
(AirSeaLand/Cody)

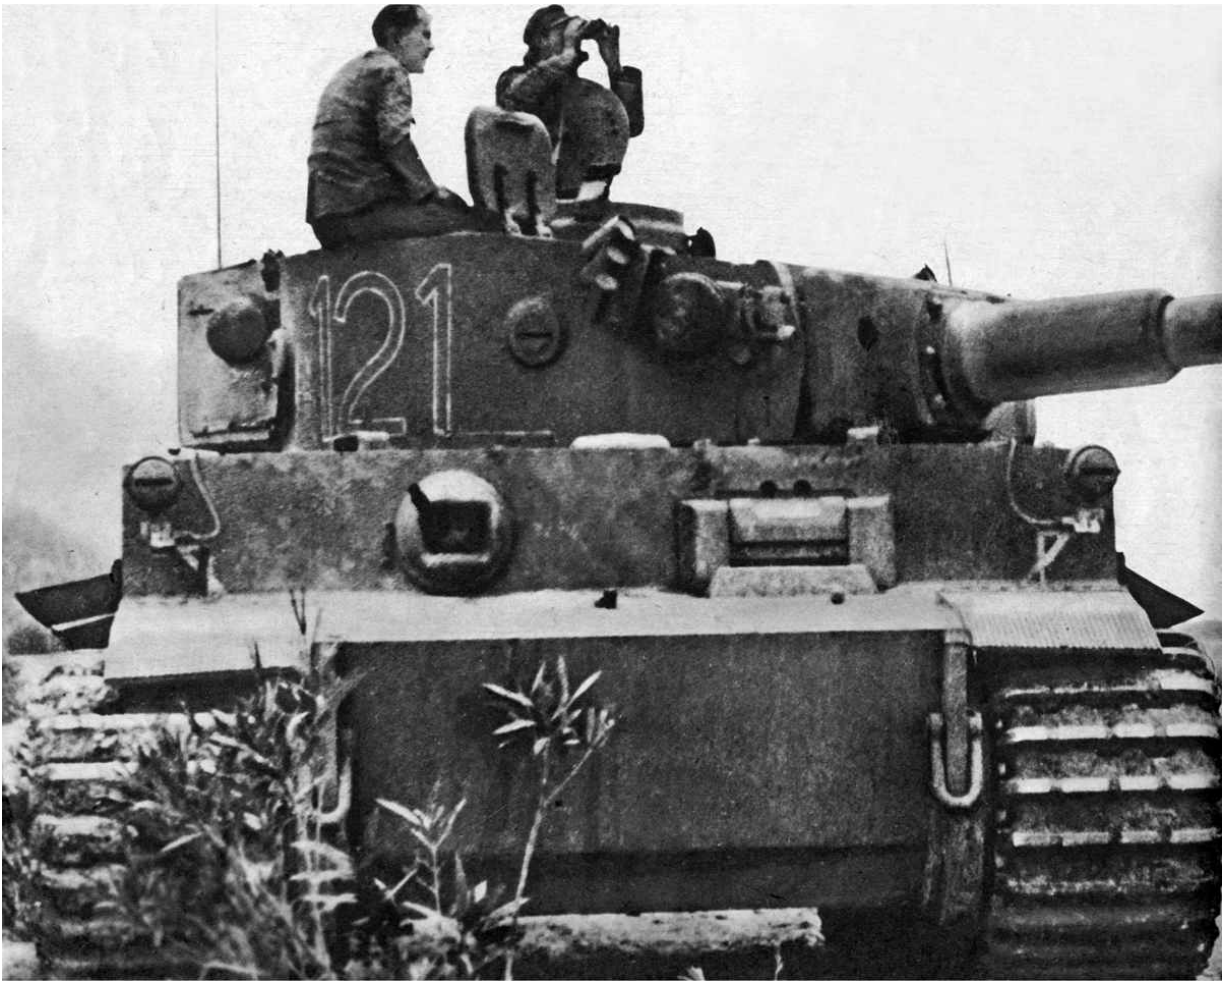
A Tiger I commander scans for enemy movement in North Africa. The two lights on the front hull are fitted with slit covers to reduce the vehicle's visibility at night. (AirSeaLand/Cody)

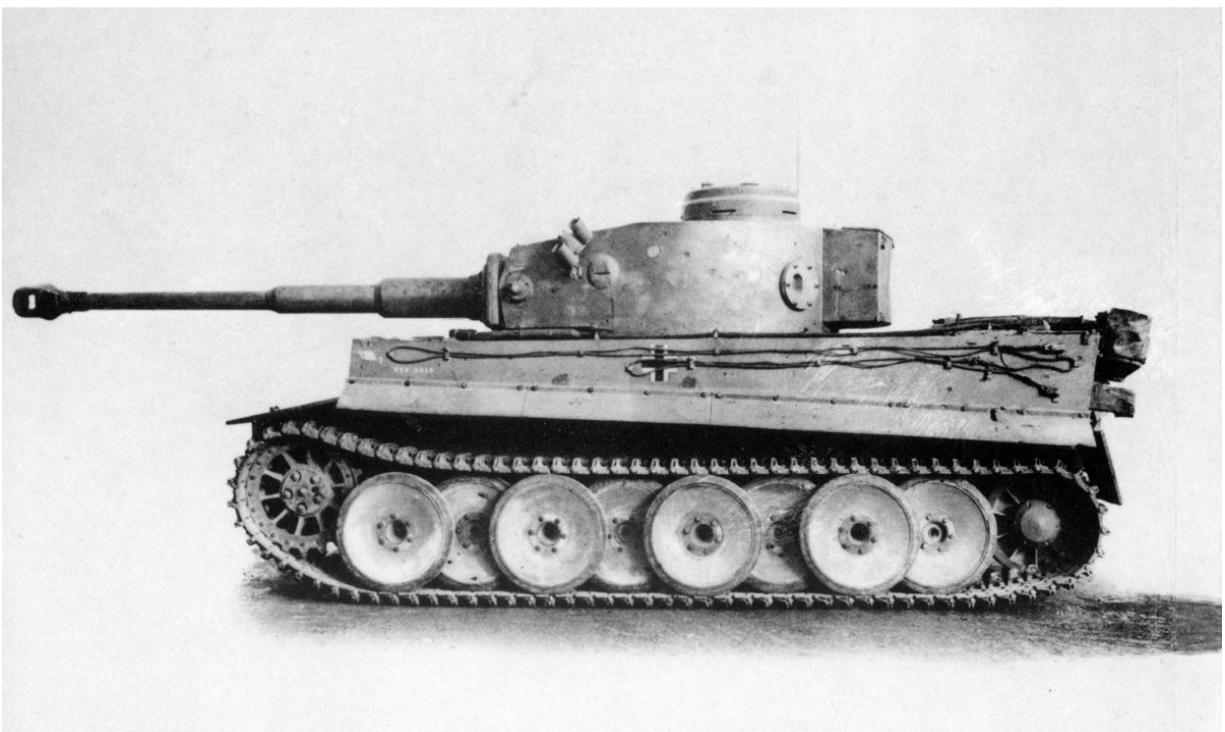
A technical manual photograph shows the side of the PzKpfw VI Tiger I. This tank features the original rubber-tired road wheels, replaced from 1943 by all-steel versions.

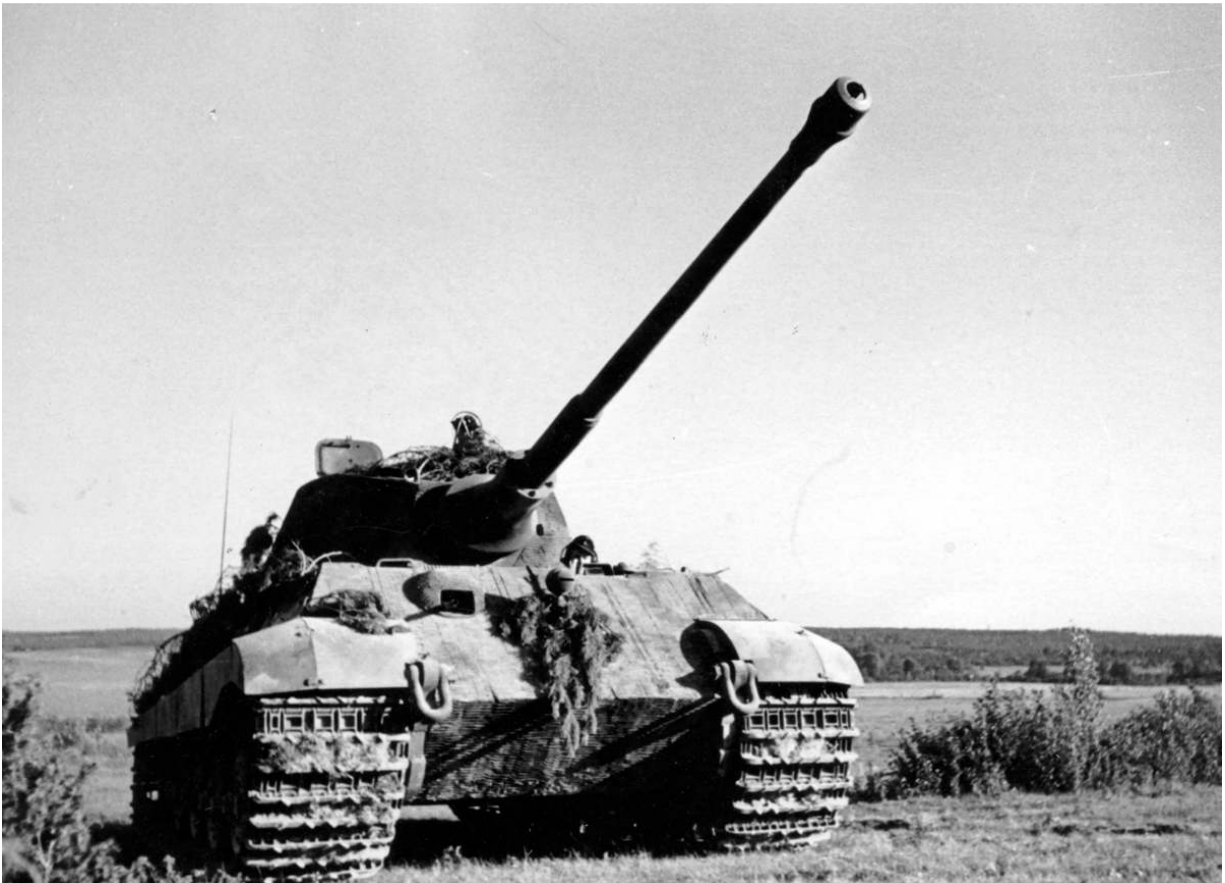
A Tiger II with its gun raised to maximum elevation; it could be elevated to $+15^\circ$ or depressed to -8° . (AirSeaLand/Cody)
